Annual Report #3 (2016)

Crowland Mitigation through Restoration of the Tamarack Bog, Bath Nature Preserve. Summit County Ohio.

Prepared by Dr. Randy Mitchell and Dr. Jean Marie Hartman

University of Akron and Rutgers University

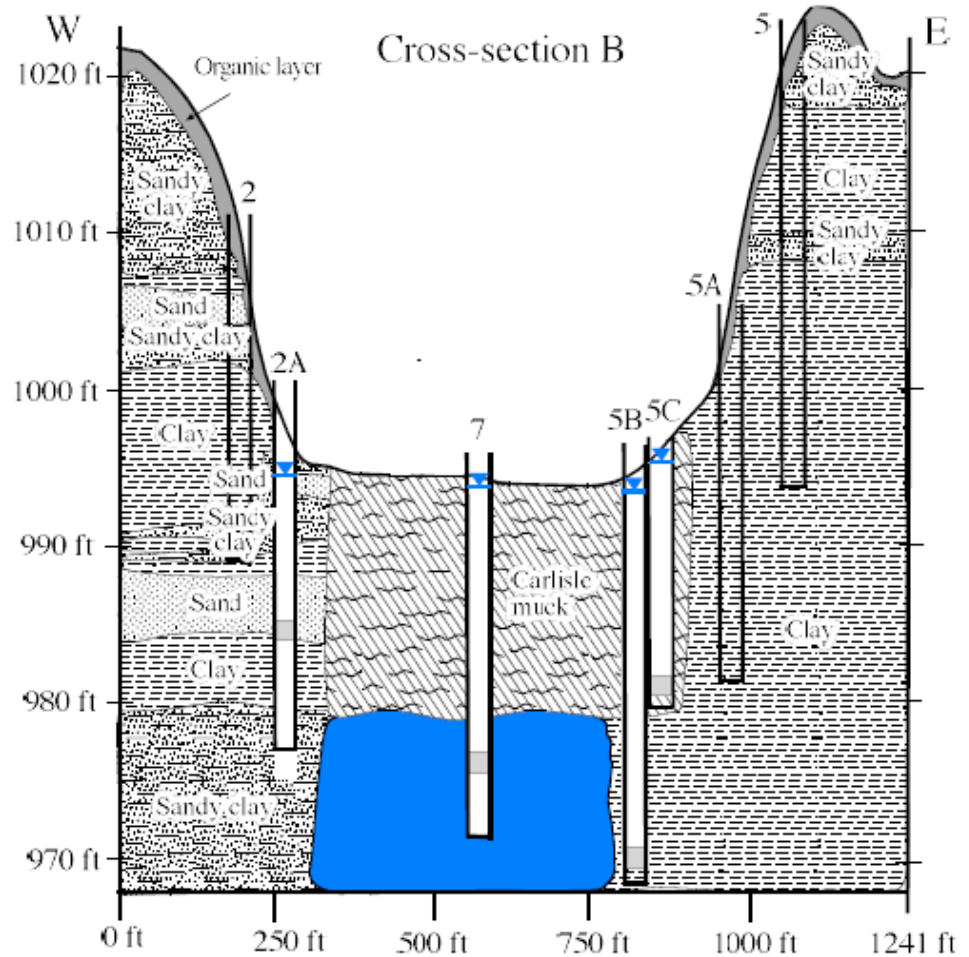
Her “Figure H2” shows a cross-section view of the subsurface material composition from some of the borings.

Based on several other cross-sections like this, she concluded that the Tamarack Bog originated as a “kettle bog” at the intersection of Hiram, Hayesville and Mogadore glacial tills. Most of the surrounding terrain is damp clay. The eastern side has some calcareous areas while the western side shows more diversity of geologic material, with several lenses of wet sand and moist sandy clay interbedded with damp clay deposits. The flat central area is mainly wet undecomposed organic matter - Carlisle muck.

Figure H2. Cross-section B from boring 2 to 5. Vertical exaggeration is 25 times. Blue line with triangles shows groundwater level (b.g.s.) on April 26, 2014. Gray box within the well casing shows the location of the screen.

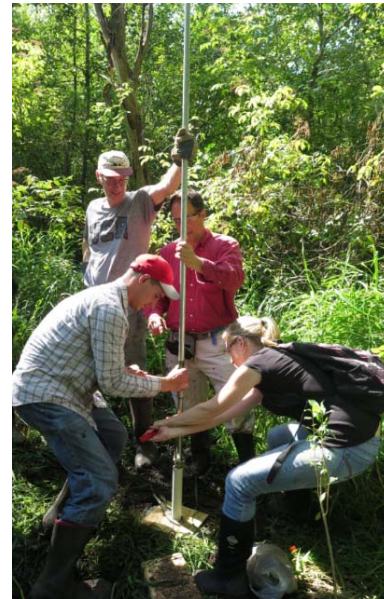
The first site is near well 7, in the middle of the bog. This station has a total of 70’ of pipe – the first 56’ or so went in under the force of gravity. The remainder of the distance we pushed the pipe down, at first with our own weight, and then for the last ~4’ we hammered it in. This left 2’ of pipe aboveground.

Prior auger samples indicate that there is 14’ of muck and peat at the surface here, with most of the depth below that to ~40 to 50’ being open water. The second site is at Well 8 (northwestern corner of bog, just south of gas pipeline). Here we used 43’ of pipe and the same combination of pushing and hammering to achieve a solid placement. The mat at Well 8 seems to be about 20’ deep (at this depth we met increased resistance), and extends all the way to the underlying clay (we saw no evidence that there is any open water under the mat here). At each site, a PVC sleeve around the upper 10’ of each fixed pipe was placed to reduce friction with any movement of the mat.

In December 2015, we placed a pressure-transducing logger at the well 7 fixed pole to record the absolute elevation of the water in the Core Bog. See photo below – the fixed galvanized pipe (shown being pushed down in the photo on the previous page) has an ‘L’ joint from which the logger is suspended in the white pipe below it, recording the absolute elevation of the water in the Core Bog (as opposed to elevation relative to the mat surface, which can be gained from the water sampling wells; see following paragraph). These data (Figure 6) parallel those from the mat level measurements above, documenting substantial water level variation over time (for the 17 days on which both instruments gave readings, the correlation coefficient is 0.87, signifying a very strong correlation). The logger data also have a greater range of variation than the mat elevation changes (total range of 0.4m, compared to 0.1m for the mat) , suggesting that the mat resists movement to some extent, and does not match the more extreme water level movements.

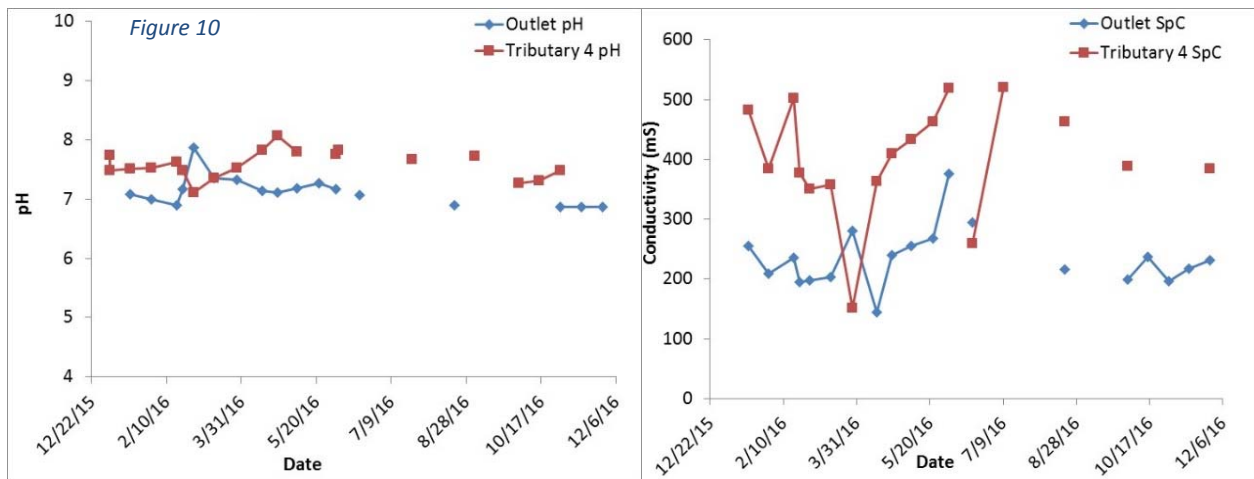
At each sampling period, we also measured pH and conductivity at the inlet and outlet of the bog, and found fairly stable values over the year (see Figure 10 below). Gaps in the lines connecting dots in these two figures indicate periods in which there was no water to sample, and this (combined with the discharge graph above) confirm that there is little to no inflow or outflow from May to October. The pH is remarkably steady overall, and slightly more basic at the inlet (mean \pm SD = 7.5 \pm 0.23) than at the outlet (7.10 \pm 0.25). Conductivity values vary more across the season, and are usually higher at the inlet (406 \pm 91mS) than the outlet (234 \pm 49 mS).

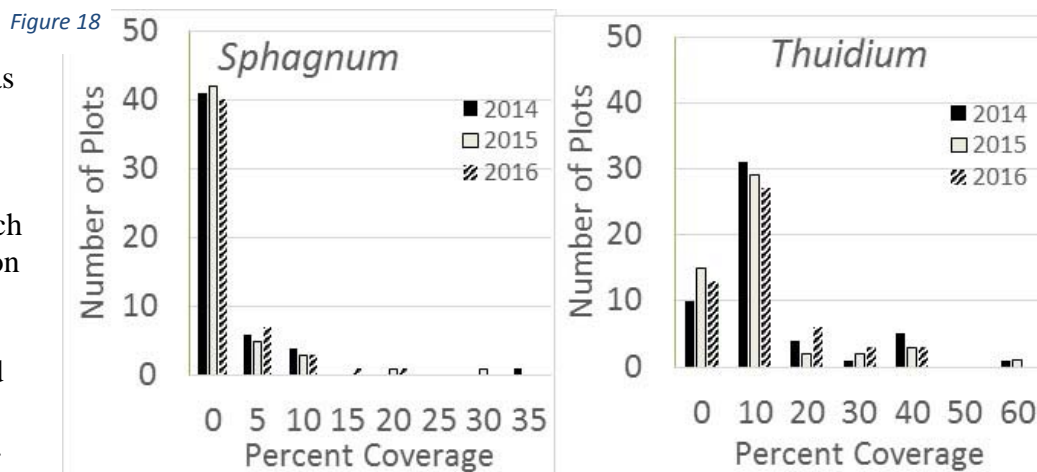
Thuidium was much more abundant overall, and was also much more common in the core areas. Leaf litter differed dramatically among areas. Core bog areas had less than 3% leaf litter cover, while other areas have over 70% litter coverage.

In our three years of moss monitoring there are two noticeable trends. First, in Core areas there has been a slight temporal decline in both *Sphagnum* and *Thuidium*. This is mostly the result of reduced cover within plots, since the number of occupied plots is holding fairly constant over

time. Second, in Edge areas there is a slight tendency for an increase in cover over time. The causes and implications of these countervailing trends are not yet clear.

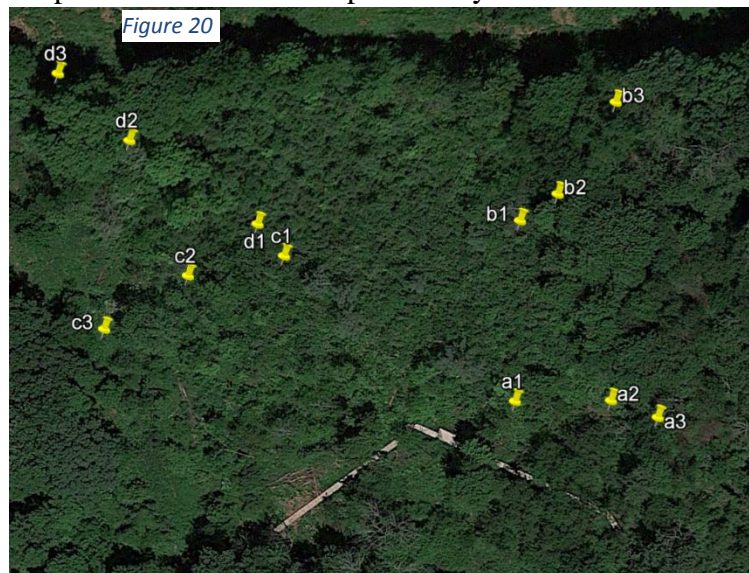
In their first summer these seedling Tamaracks (~50cm high at transplanting) grew on average 2.88 cm (SE= 0.58; See Table 5), with a tendency to grow faster in the enhancement and edge habitat than in the core ($P < 0.06$). Our impression was that this tendency reflects shadier conditions in the core.

Over 75% of tamaracks survived through to October, with most deaths, apparently, the result of herbivory by deer. Indeed, nearly half of the transplants suffered at least some deer herbivory. In general, plants in the core bog had lowest survival and highest herbivory, which is mildly surprising given the very dense woody vegetation and difficult soil surface there. One aim of this trial was to evaluate whether herbivores would be an important issue for future transplants—clearly it is.
