Annual Report #5 (2020)

Crowland Mitigation through Restoration of the Tamarack Bog, Bath Nature Preserve. Summit County Ohio.

Prepared by Dr. Randy Mitchell and Dr. Jean Marie Hartman
University of Akron and Rutgers University

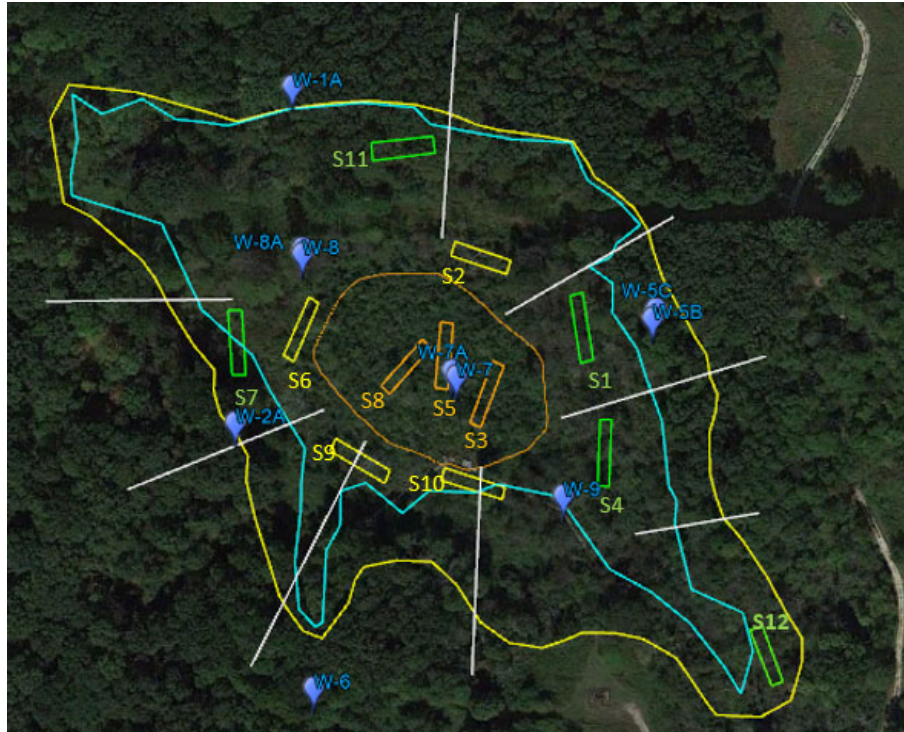
Figure 1. Locations of major landscape and monitoring elements of the Tamarack bog restoration. The irregular yellow line surrounding the area is the target wetland extent expected following a successful restoration, the irregular blue line indicates the wetland boundary as delineated in May 2013, and the irregular orange line indicates the approximate 2013 location of the “Core Bog” plant community. Rectangular boxes indicate the 11 VIBI modules (each 25m x 5m); the orange boxes are ‘Core’ modules, the yellow boxes are ‘Edge’ modules, and the green boxes are ‘Enhancement’ modules. Plot “S12” is newly added in 2019. The 8 white lines indicate the vegetation transects. The blue points and lettering indicate water monitoring wells referred to in the text. This image shows portions of the boardwalk (installed 2015) in the center-south.

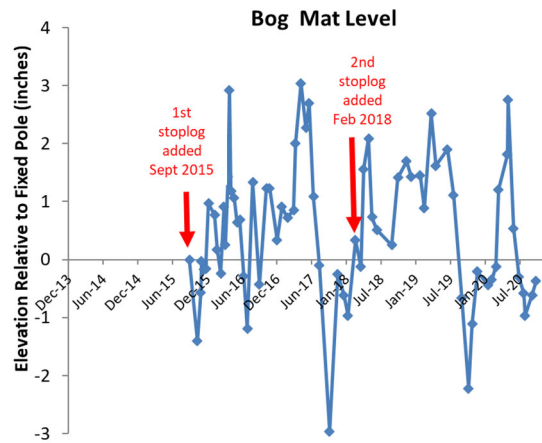
Figure 4. Bog mat level relative to fixed elevation pole. N=4 readings per data point; the data points are the means of the relative heights of 2 permanent marks at 2 stations. Last reading in December 2020.

height of the mat relative to those poles we can monitor any ‘floating’ of the mat ("mooratmung") driven by changes in the underlying water level. In Figure 4 we summarize all mat height measurements since installation).

These data indicate that the mat is floating relatively freely. During spring floods, the mat rose to as much as 3.04” above the arbitrary initial height, and during summer dry spells it sinks to as low as 2.96” below the initial height, for an overall amplitude of 6” so far. That range has reduced slightly since the addition of the second stoplog (-2.22 to 2.75" vs. the values above). Mean height has increased slightly since Feb 2018 (0.51" through Feb 2018, and 0.60" since then). These patterns suggest that with the current stoplog height the mat still floats freely and is unlikely to be completely submerged except during the spring-time melt. Based on these data and on vegetation responses we do not see a need to raise the stoplog further, but are willing to do so if EPA or USACE feel it is advisable.

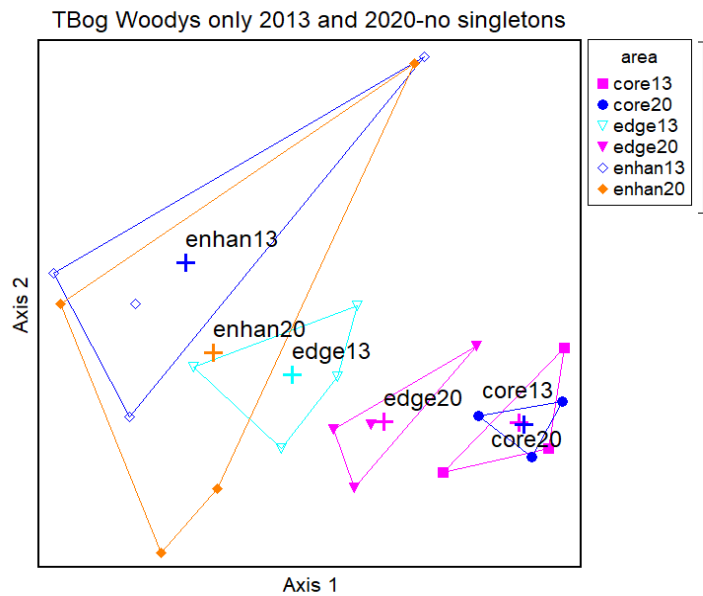
Figure 10. Ordination plot (NMDS) comparing initial conditions (2013 to current conditions (2020) for the three habitats in the wetland. Based on woody stems. Crosses indicate centroid of each color-coded convex hull.

To better visualize community change over 8 years, we conducted a second NMS analysis for only the data from 2013 and 2020, to compare 'before' to 'current' communities. There were only 27 species in this two year ordination, and because of the requirements of the analysis, the geometry of the figure and meaning of the axes is slightly different. Nonetheless, there are strong patterns matching those in the 8 year figure. Furthermore, there are interesting and important temporal trends to be seen here. In particular, the Core is not really changing, the Edge habitats are changing to become more like the Core, and some of the Enhancement plots are also moving toward the Core and Edge conditions. Note that the two lowest points in the orange "Enhan20" group (Enhancement plots for the year 2020) are for plots S1 and S4 – those two plots are on the far east of the wetland, where there is extensive vegetative change (increase in herbaceous cover and young Green Ash).

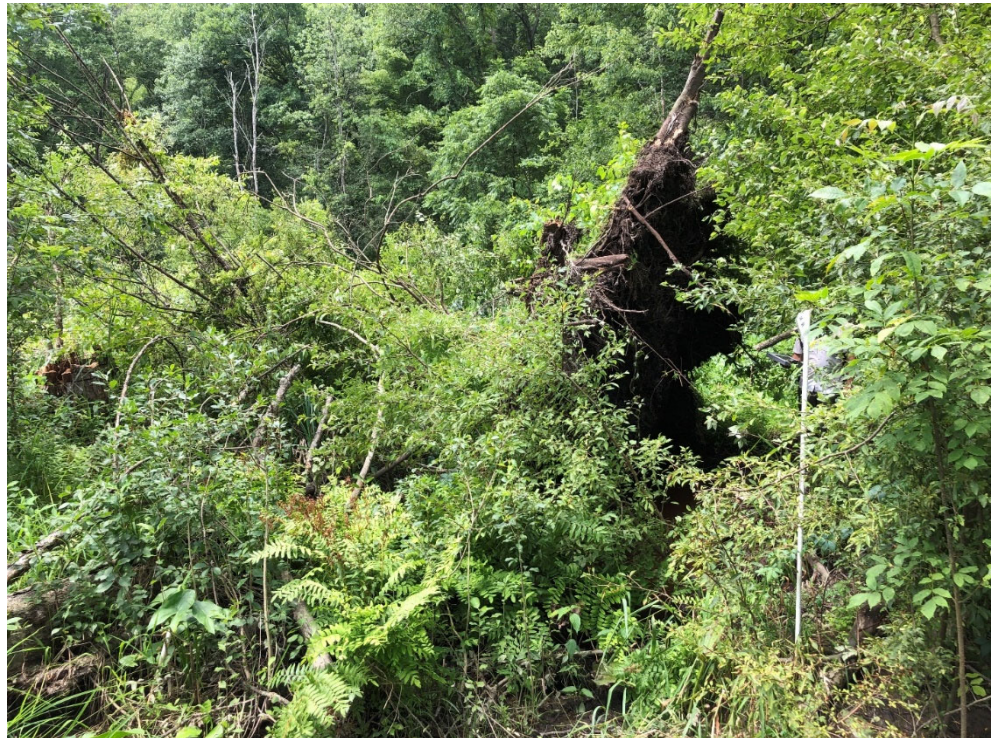
Figure 16. Large trees are falling. July 2019 - large red maple (~100cm dbh) fell west along the length of plot S2 (the day after we censused that plot). Not the height (over 7') and shallow nature of the rootwad, and the ~5.5' tall white plot stake alongside it.

This is in part a response to girdling efforts by Davey Tree, and in part a function of toppling by Green Ash trees killed by Emerald Ash Borer. Beyond this, however, a large portion of these are shallow-rooted trees (especially red maple and cherry) that are unstable now that water levels are higher. Often these falling trees produce large

root wads over 6' tall (Figure 16, Figure 17). We are now working to document the increase in treefall using remote sensing image analysis.

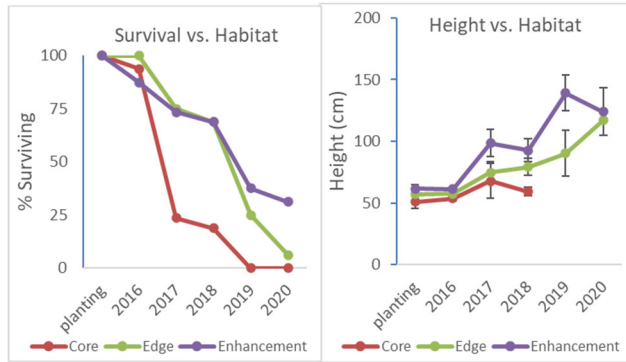
Figure 19. Survival and height of Tamarack transplants.

Although initial survival was strong, only 10% of the planted seedlings now survive, 4 years later. A large portion of this mortality came from two sources. First, the Core was just a tough place for us to plant seedlings and for them to grow. The soil is unconsolidated and often obstructed by roots, and the habitat is extremely shady. By 2019 none of the seedlings in the Core habitat survived, so 1/3 of the overall mortality (across the three habitats) is probably the result of that being a poor place to transplant. Second, there was extensive herbivory (mostly by deer) in 2016. Indeed, nearly half of the transplants suffered at least some deer herbivory in the first year. In general, plants in the Core bog had lowest survival and highest herbivory, which is mildly surprising given the very dense woody vegetation and difficult soil surface there. One aim of this trial was to evaluate whether herbivores would be an important issue for future transplants- clearly that is the case. At this point 5 of the initial 48 transplants still survive (all but 1 are in the Enhancement area).

Growth of the surviving plants in the Edge and Enhancement areas has been strong, with substantially better growth in the Enhancement areas until 2020. Plants have more than doubled in size over 4 years, and the largest transplant is over 1.8m tall.

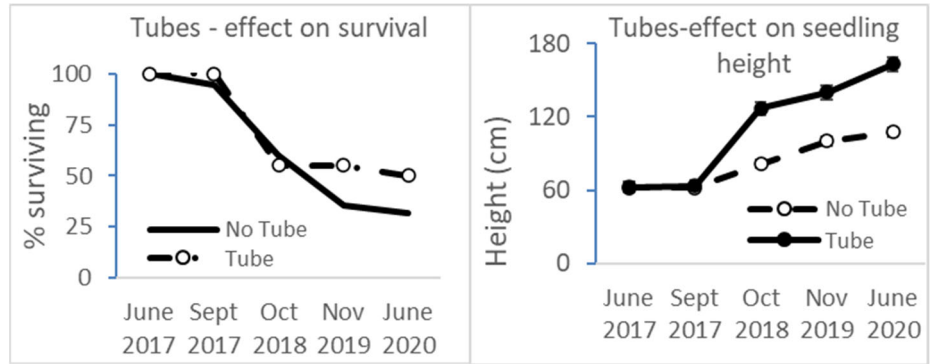
Figure 21. Survival and height of Tamarack transplants II with respect to herbivory protection via tubes

Herbivore protection tubes seemed to affect both survival and height of seedlings. Note that sample size is small (only 20 total trees in tubes across the 10 plots). Survival was higher in tubes (by June 2020, 50% survived with tubes, while 31% survived without tubes). It's worth noting that survival in tubes would probably have been slightly higher, but in several cases the tube was dislodged by flooding, and pulled the seedling out of the ground. This should be preventable with more careful tube placement.

Seedlings in tubes grew to be more than 50% taller than those not in tubes (163 vs 107cm). Our impression was that the seedlings in tubes were robust, and not spindly. Indeed, one tree reached over 250cm in height and had a substantial trunk.

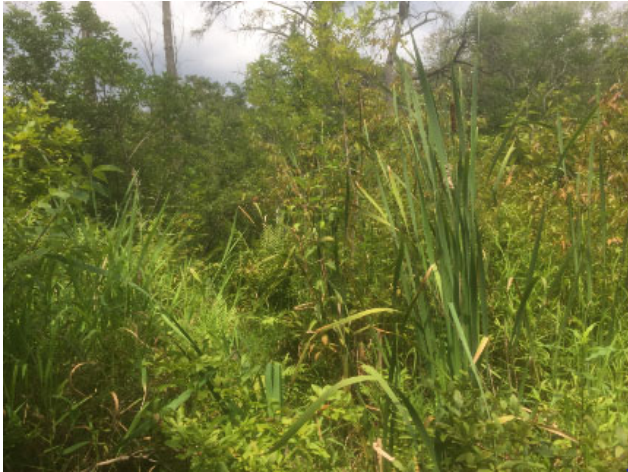
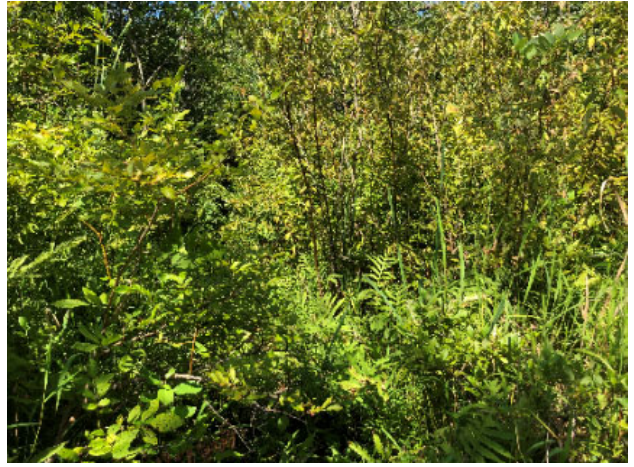
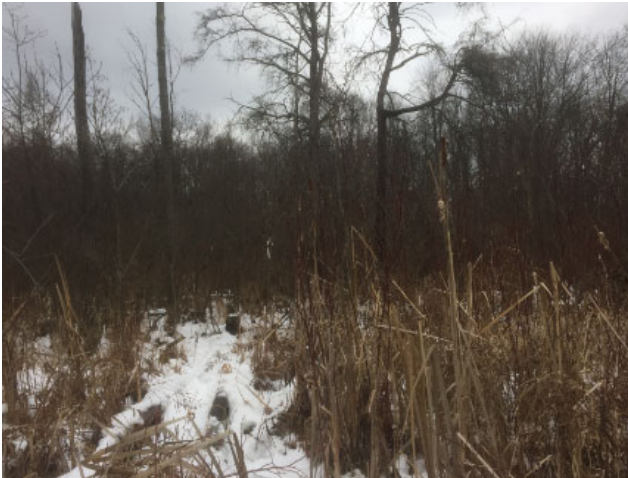
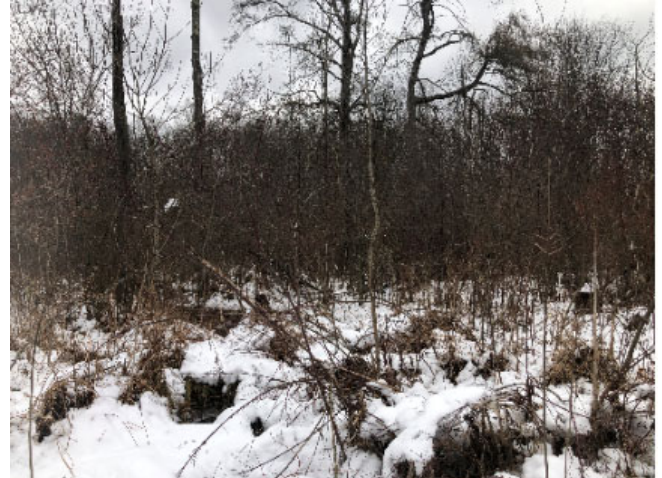
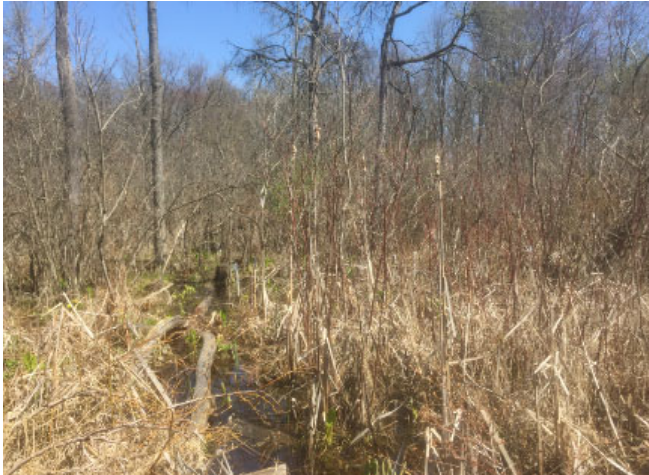
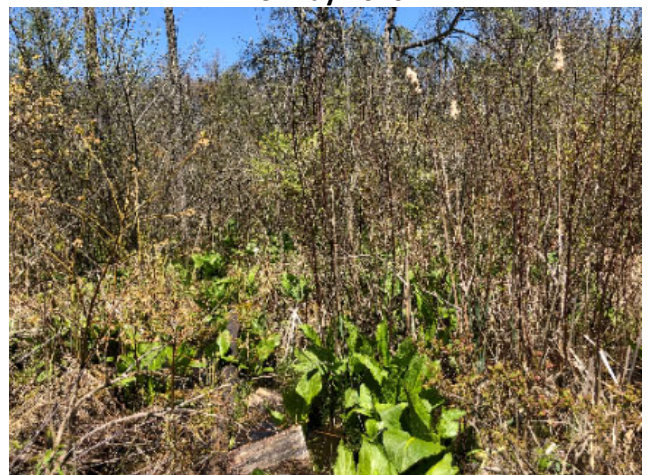
Repeat Photos Station R3 (next page). Selected photos (Extracted from Appendix E - Plot Photos)
This plot in the middle of the boardwalk, looking toward the core bog. Left column is earliest available photo for each month, right column is most recent available photo. Note tamarack trees in background, and reduced cover of *Typha*.
