Final Report (2023, 6th Report)

Crowland Mitigation through Restoration of the Tamarack Bog, Bath Nature Preserve. Summit County Ohio.

Prepared by Dr. Randy Mitchell and Dr. Jean Marie Hartman
University of Akron and Rutgers University

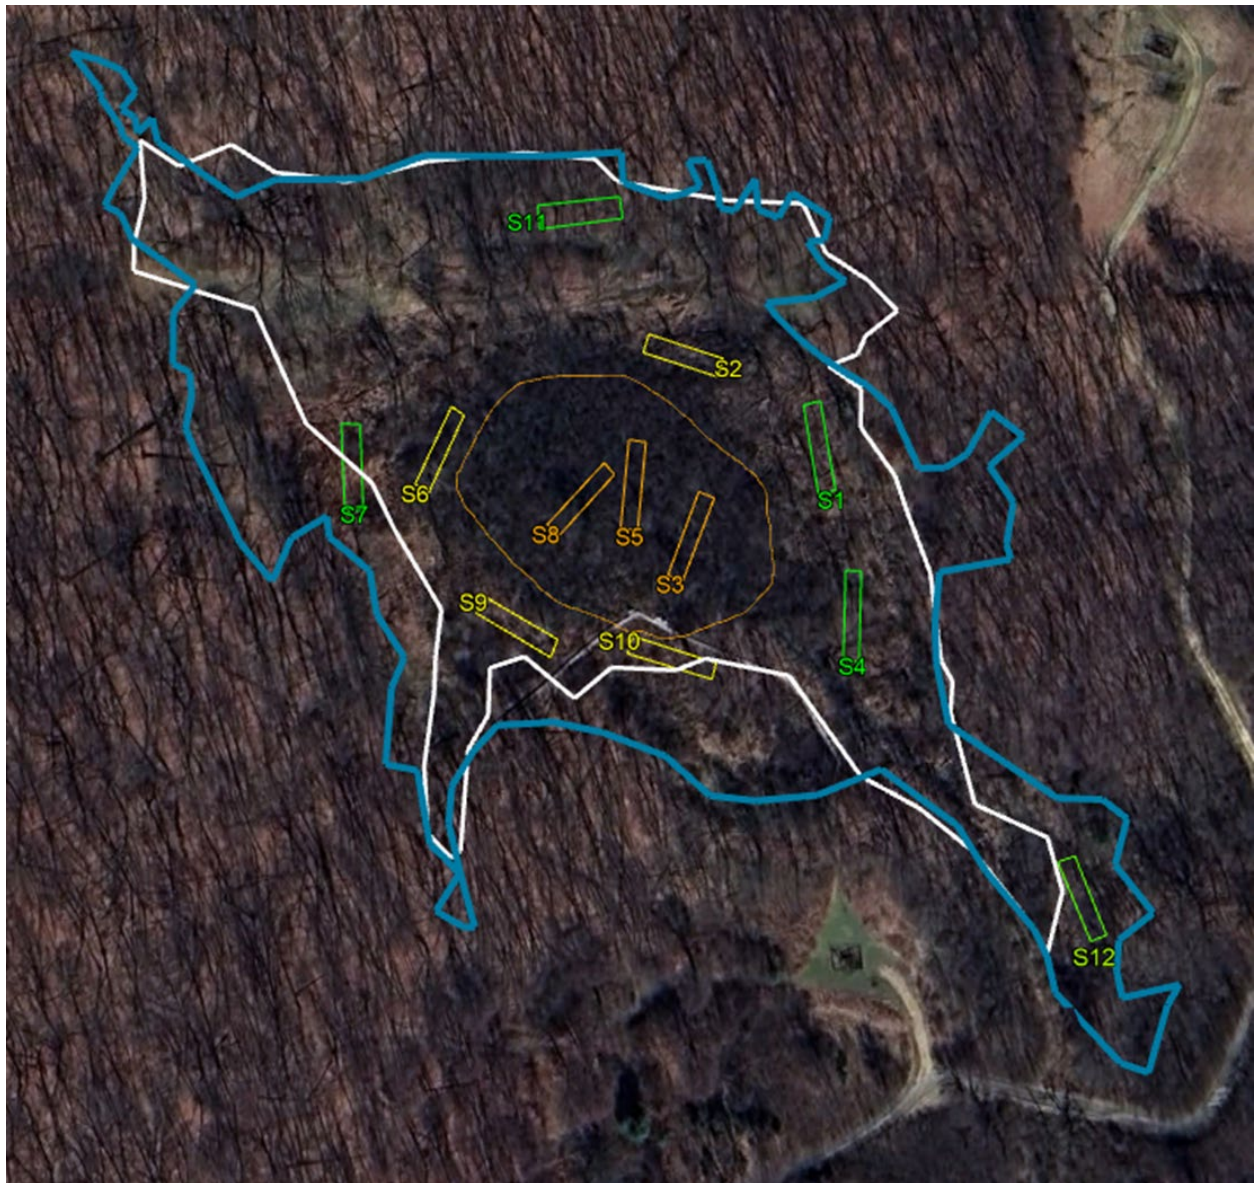
Figure1: Site Boundaries and Monitoring Sites.

The irregular white line shows the 2013 wetland boundary.

The irregular blue line shows the 2023 wetland boundary.

The irregular orange line, towards the center shows the Core wetland.

Elongated rectangles identify annual sampling plots, color coded to indicate their wetland zone.

We expected to maintain conditions in the CORE, and to improve conditions for wetland species dominance in the EDGE. Furthermore, we expected to create the possibility for more wetland species to spread into the ENHANCEMENT zone. We anticipated limited expansion of wetland conditions through increased seasonal water coverage and expansion of wetland species where appropriate topography exists. Figure 1 is an aerial photo that shows the site in 2015.

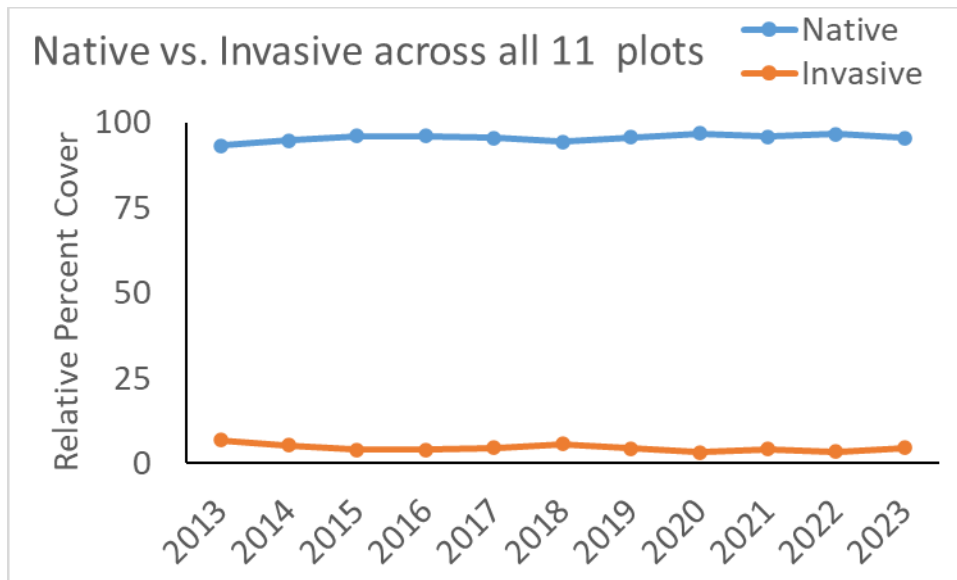
Figure 4. Mean relative percent cover of Native vs. Invasive species across all 11 plots.

Item 18, 19, Item H7: Percent cover of native perennial hydrophytic vegetation across the sample plots started off at 60% in 2013, and by 2023 had increased to 80.4%, well above the target of 75%. Overall cover of the wetland by invasive non-native species is below the target of 5%, decreasing from 6.8% in 2013 to 4.5% in 2023 (Figure 4). Both of these targets have been achieved.

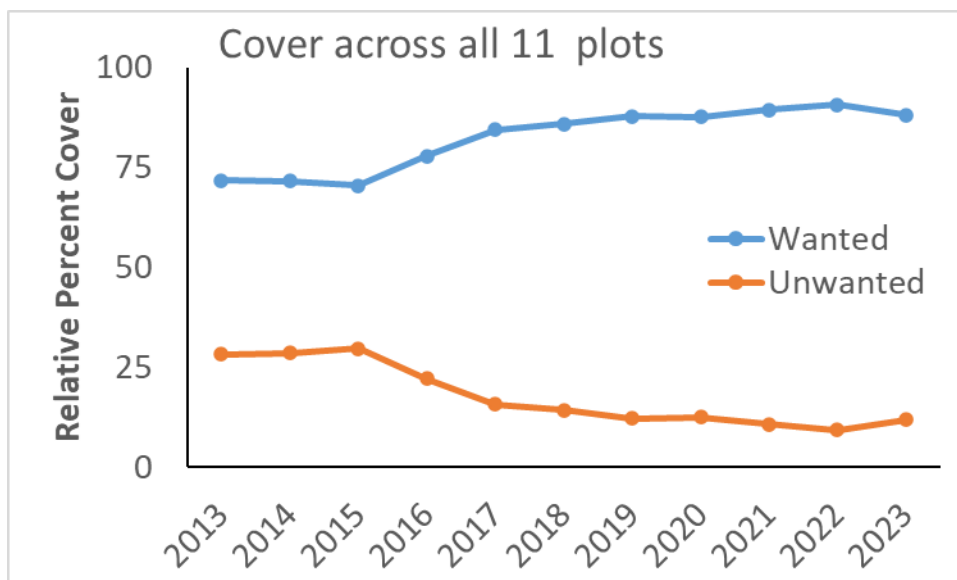
Figure 5. Mean relative percent cover of wanted vs. unwanted species. Unwanted species include invasive non-native species and several native species that are not contributing to habitat quality (Red Maple, Crabapple, and Black Cherry).

For this project there were important concerns about not just non-native invasives, but problematic native species, especially Crabapple and Red Maple. Cover for these “Unwanted Species” has strongly decreased over the 10 years of monitoring, from 28% relative cover to 12% relative cover. (Figure 5). Most of this decline is in Crabapples (*Pyrus* spp.) and Red Maple (*Acer rubrum*), which have dropped from 25-30% absolute cover to about 10-15% absolute cover. This reflects vigorous and focused control efforts (mostly girdling) by Davey Tree, and an improved method of girdling since 2016.

Our results and experience indicate that the invasive control efforts now in place (along with the change in hydrology) are having strong positive effects. We also conclude that continued aggressive control of invasive species will be necessary to maintain the currently high-quality project area. Based on the Bath Township covenant (APPENDIX C), continued invasive species control efforts are required to continue under the direction of Bath Township.

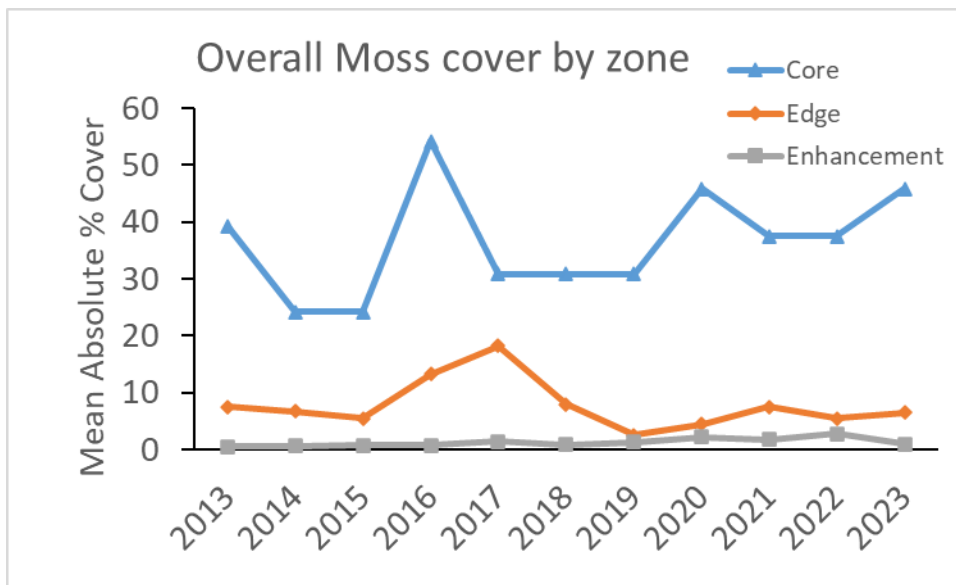
Figure 8. Mean absolute percentage cover by Moss (all species) in the three habitat zones.

First: Sphagnum coverage held fairly steady over the 10 years of the restoration (1.2% absolute cover in 2013 in Core plots, 0.8% in 2023), and Sphagnum actually expanded into one Edge plot (Plot S10) in the last 4 years.

Second: Many other moss species are important components of the Core zone. In particular, *Thuidium delicatulum* (Delicate Fern-Moss) is a very abundant moss in the area (and in fact, it may have been confused with Sphagnum in the initial evaluations that generated the restoration targets). Our results suggest no strong pattern of change in moss cover (Figure 8).

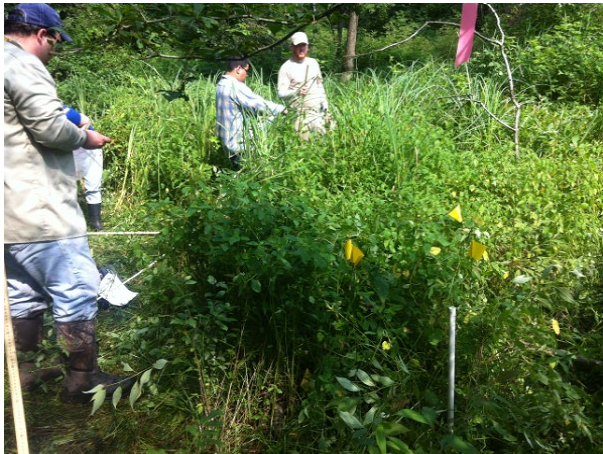
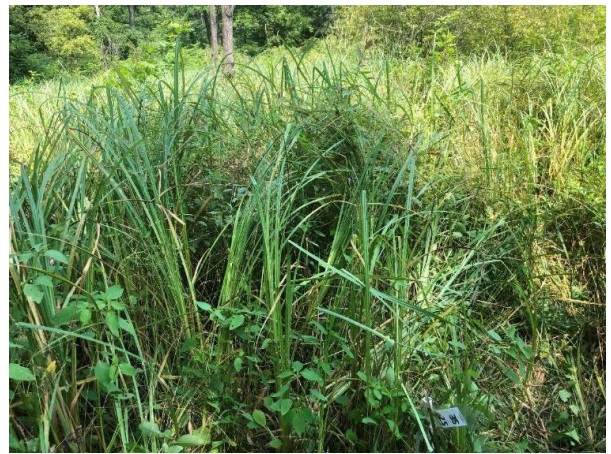
Plot S7 August 2014 (Enhancement). From SE.

July 2023 Plot S7 SE. Lake Sedge expands. Silky dogwood in upper right is steady

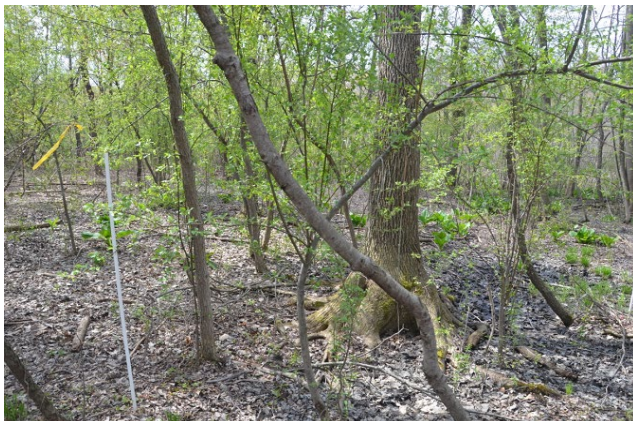
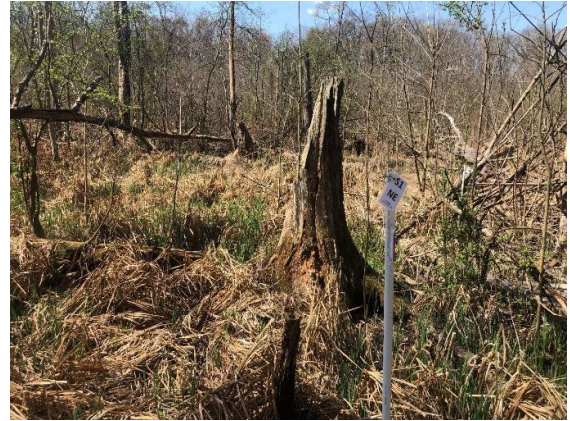
Plot S1 May 2015 (Enhancement): From north.

May 2023 Plot S1 NE.

The large central tree has fallen, as has the sapling to its left. Enormous increase in Lake Sedge, and reduction in crabapple

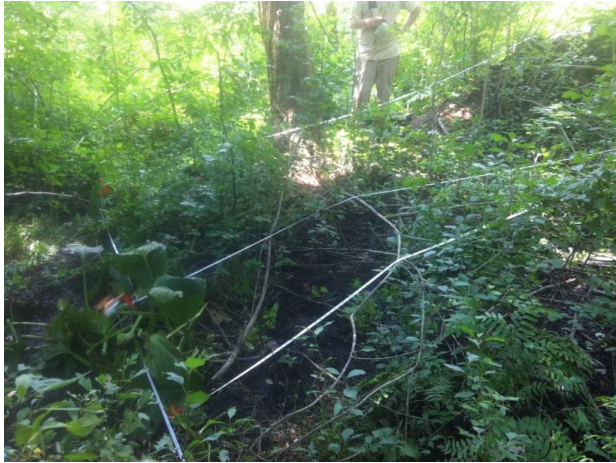
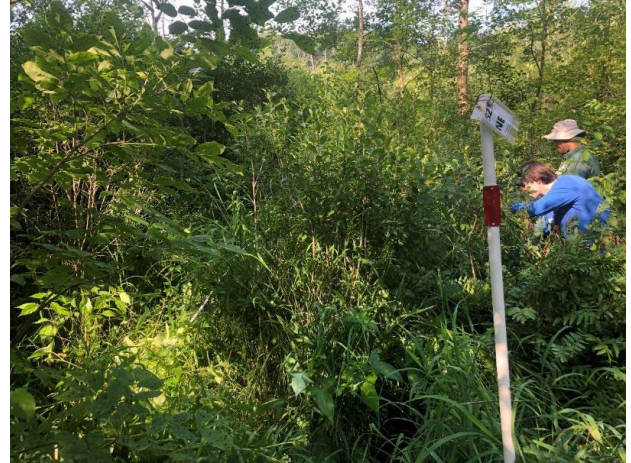
Plot S2 July 2014 (Edge) Plot S2 from NE

July 2023 Plot S2 from NE corner (note Meter tape in center left). Strong increase in herbaceous and woody cover.

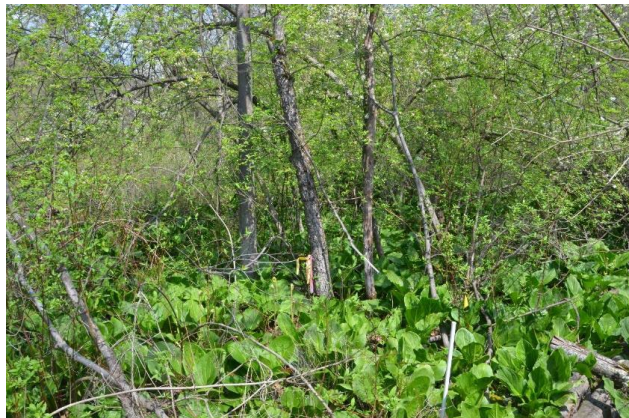
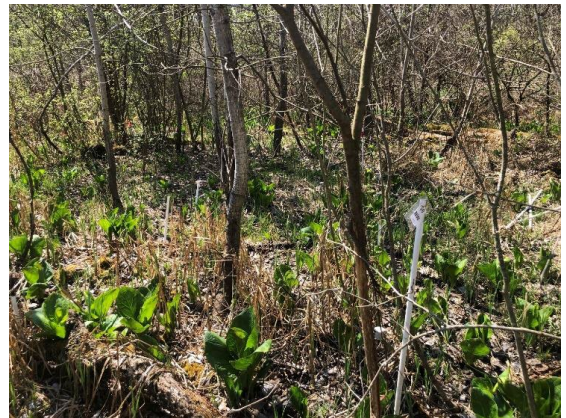
Plot S9 May 2015 (Edge). Plot S9 from NW

May 2023 Plot S9 NW corner. Skunk cabbage perseveres, Lake Sedge and Quaking Aspen arrive, woody vegetation matured.

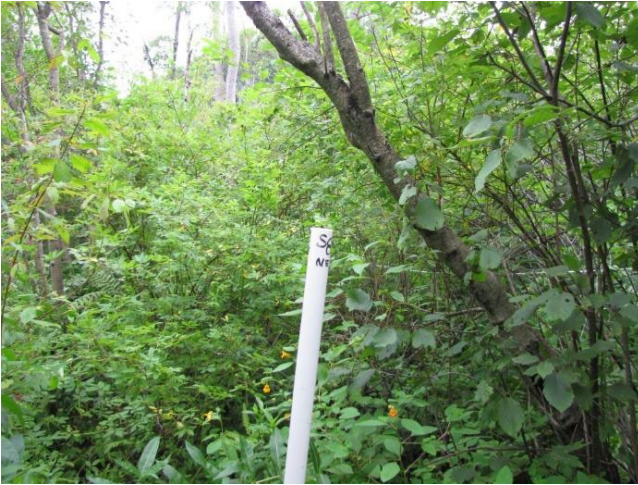
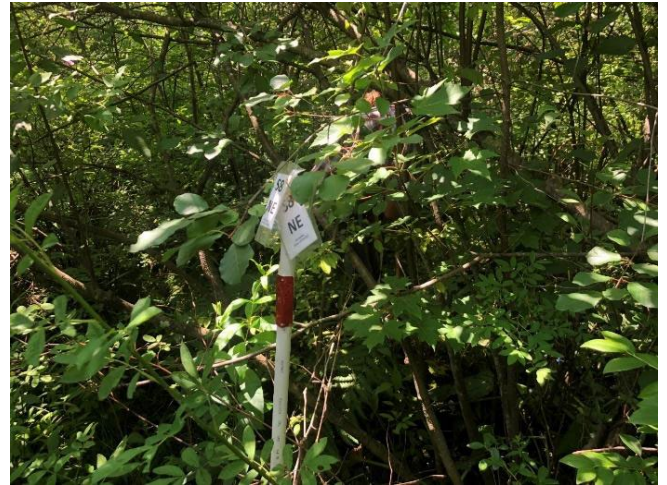
Plot S8 August 2014 (Core): S8 NE Corner to SW

July 2023. Plot S8 NE, view to SW.
The thick woody veg. remains in place.

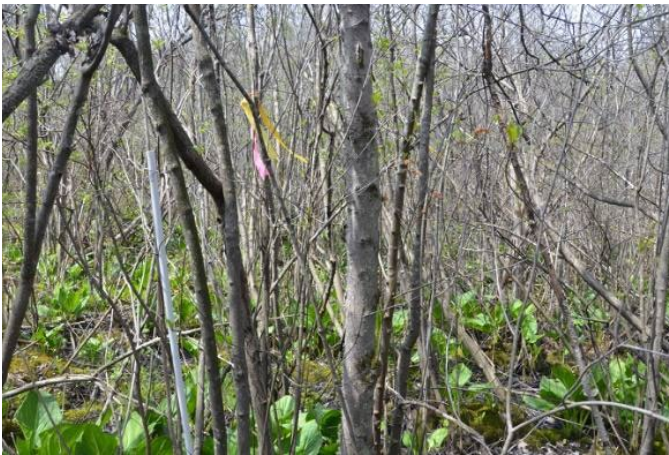
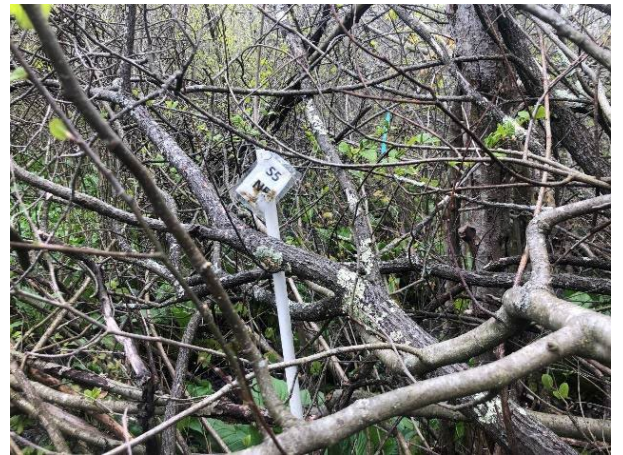
Plot S5 May 2015 (Core): Plot S5

May 2023 Plot S5 NE. A large shrub has fallen into the plot, but veg structure is consistent over time, skunk cabbage remains abundant.

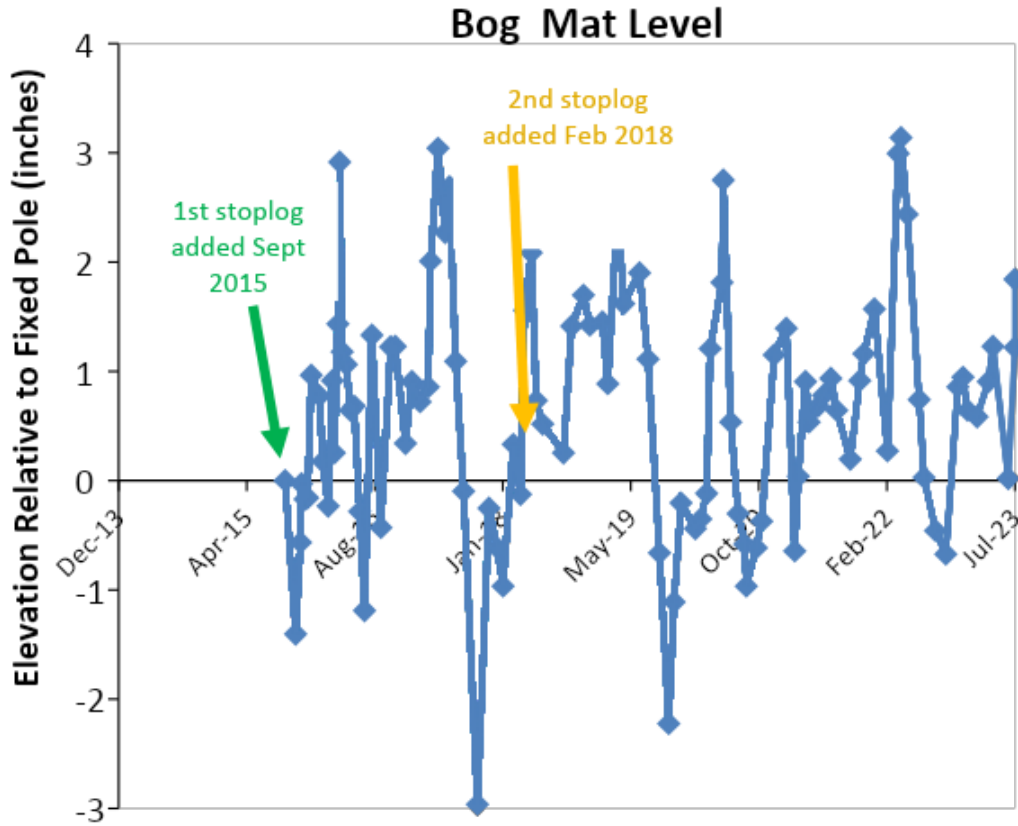
Figure 11. Absolute elevation of the bog mat.

Second, we have continued monitoring the absolute elevation of the peat/muck mat of the wetland using a fixed pole at two points in the wetland (Figure 11; see previous reports for methodological details). These data confirm that the bog mat floats on an underground pond.

Since the pond varies its elevation with the seasonal variation in water availability, the mat also rises and drops, with an amplitude of ~6". These fluctuations match those of the outlet level but with reduced amplitude. This elasticity has insulated the vegetation of the Core bog from the raised water level, preventing extreme flooding and potential drowning risk.

Note that y axis in this graph is in inches, while that for the previous figure is in feet. The mat fluctuates in height by about 6" over the yearly cycle.
