WETLAND AND WATER RESOURCE DELINEATION REPORT

16.40-Acre (Approximate) Portion of a 369.1-Acre Parcel 4240 Ira Road
Akron, Summit County, Ohio
(Parcel ID 0406882)

April 27, 2023

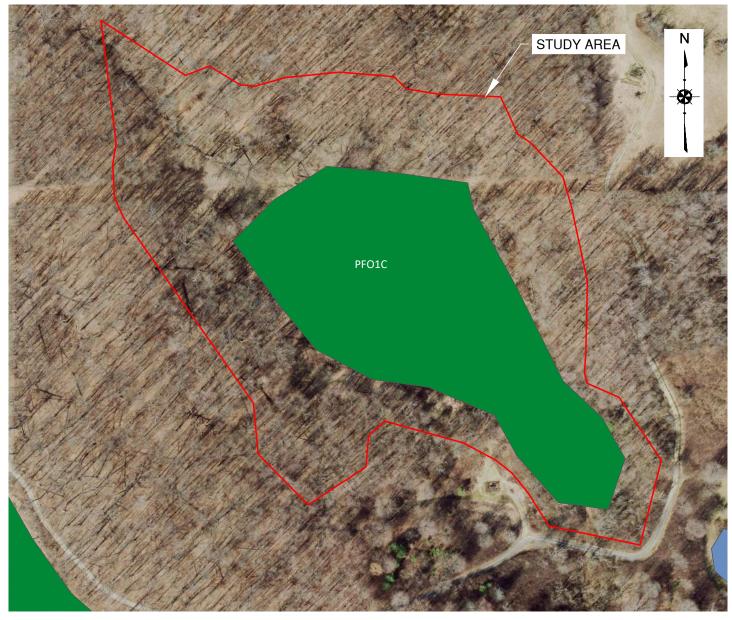
U.S. Fish and Wildlife Service National Wetlands Inventory

A review of the USFWS National Wetlands Inventory (NWI) map of West Richfield, Ohio indicated the presence of one (1) PFO1C wetland within the Project Area (**Appendix A, Figure 2**). PFO1C is defined as a palustrine system dominated by broad-leaved, forested vegetation that is seasonally flooded. No streams are indicated on NWI mapping. Note that NWI maps were derived from aerial photo interpretation and are designed for general planning purposes only.

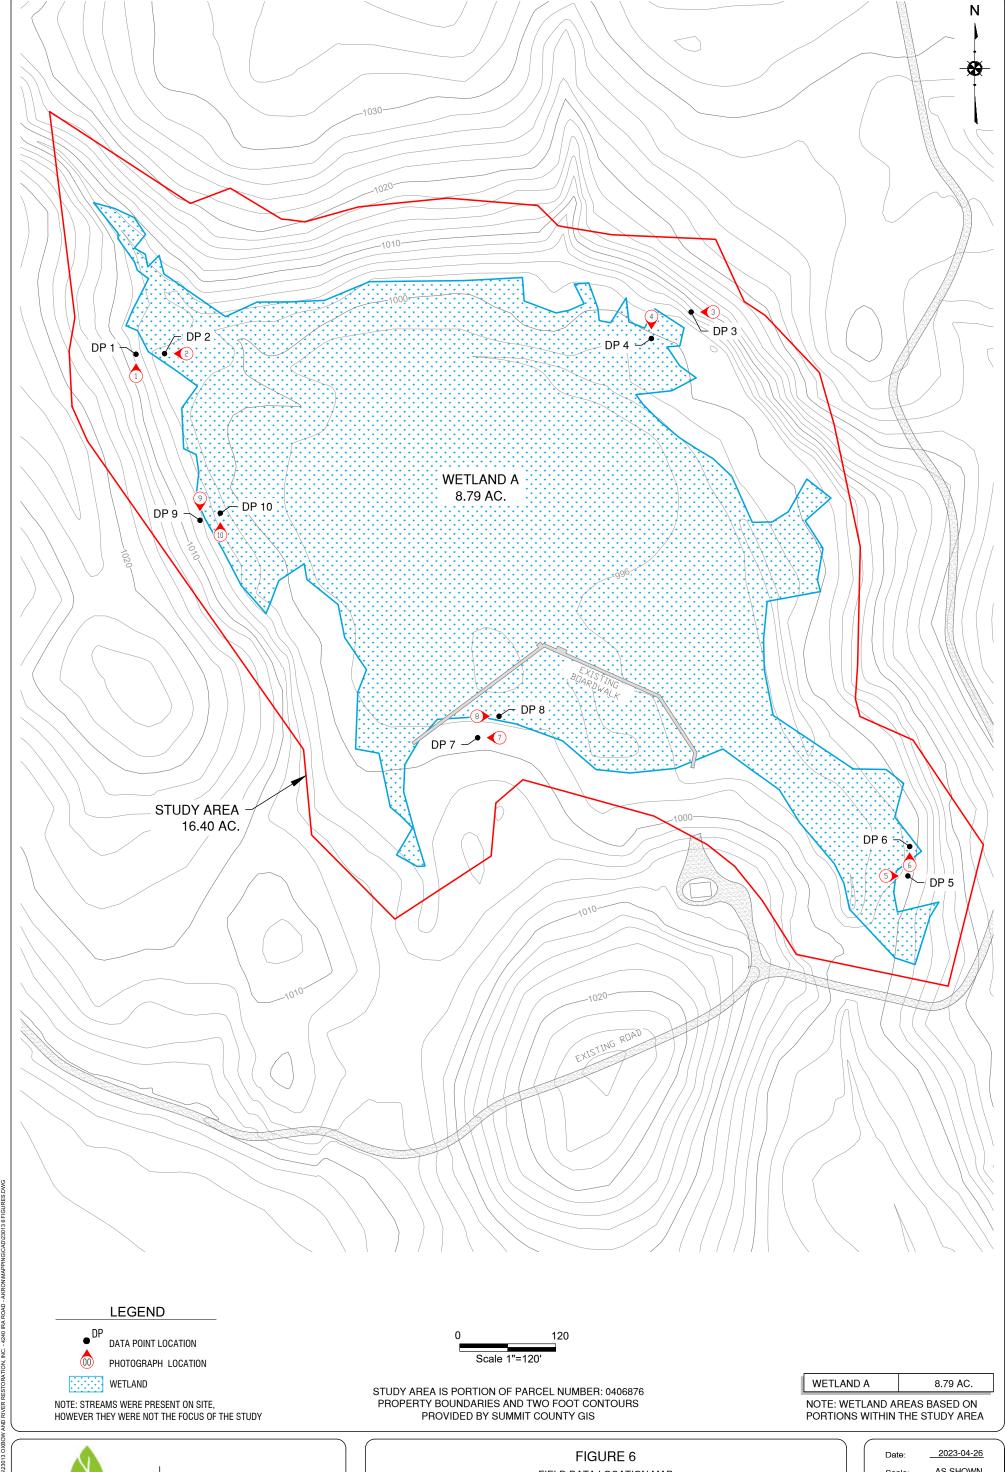
Land Solutions, LLC 34600 Chardon Road, Suite C Willoughby Hills, Ohio 44094 FIGURE 6
FIELD DATA LOCATION MAP
OXBOW AND RIVER RESTORATION, INC.
4240 IRA RD., AKRON, SUMMIT COUNTY, OHIO

Streams were observed within the Project Area. However, based on the focus of this study, stream location data was not collected and is not indicated on the Field Data Location Map (**Appendix A, Figure 6**).

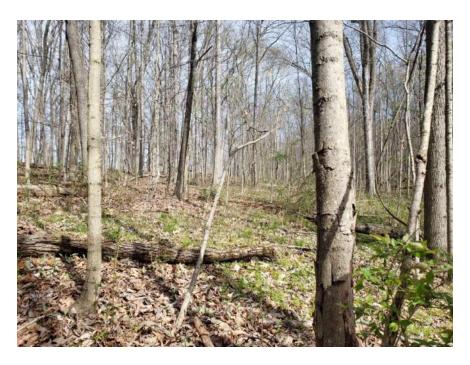
Photograph 1

View facing north showing the forested habitat at non-wetland data point DP1, captured in the northwestern portion of the Project Area.

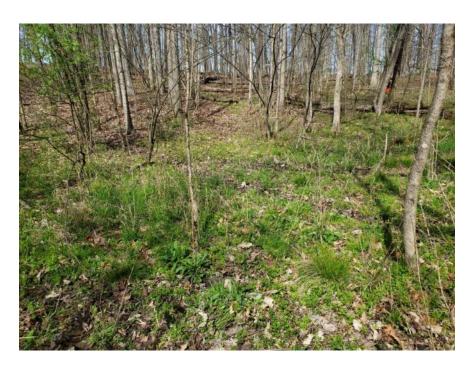
Photograph 2

View facing west showing the forested habitat with emergent understory of Wetland A at data point DP2, captured in the northwestern portion of the Project Area.

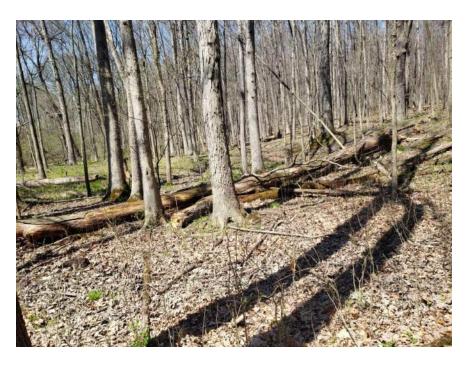
Photograph 3

View facing west showing the forested habitat at non-wetland data point DP3, captured in the northeastern portion of the Project Area.

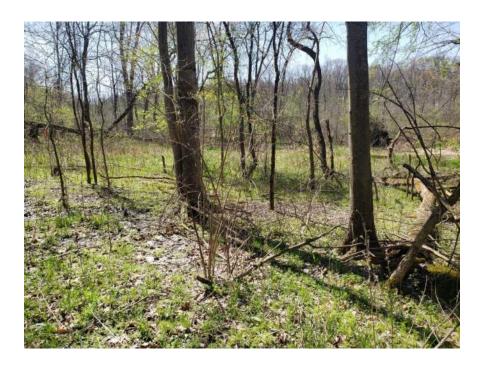
Photograph 4

View facing south showing the emergent habitat of Wetland A at data point DP4, captured in the northeastern portion of the Project Area.

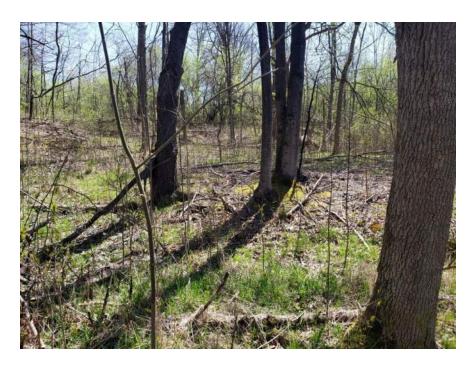
Photograph 5

View facing east showing the forested habitat at non-wetland data point DP5, captured in the southeastern portion of the Project Area.

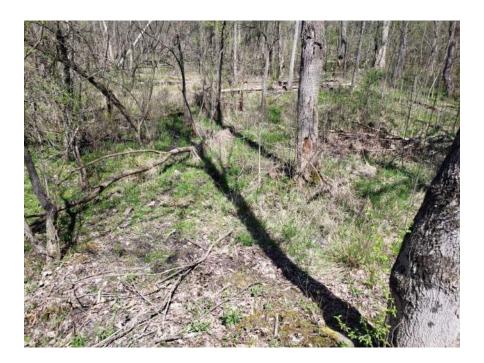
Photograph 6

View facing north showing the emergent habitat of Wetland A at data point DP6, captured in the southeastern portion of the Project Area.

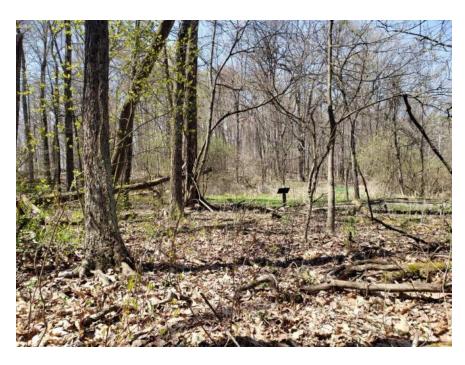
Photograph 7

View facing west showing the forested habitat at non-wetland data point DP7, captured in the southwestern portion of the Project Area.

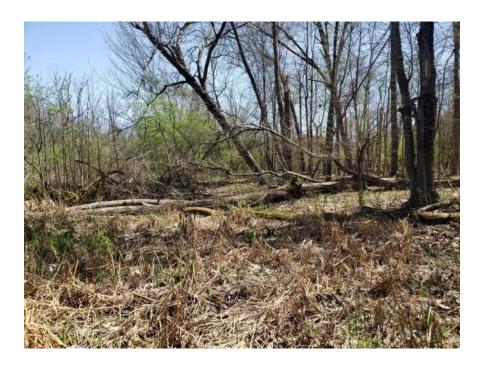
Photograph 8

At data point DP8, the tree stratum did not consist of any plants. The shrub stratum consisted of *Rosa palustris* (swamp rose) and *Lonicera tatarica* (Tatarian honeysuckle). The dominant herbaceous stratum consisted of *Phalaris arundinacea* (reed canary grass) and *Typha X glauca* (hybrid cattail). Positive primary hydrology indicators of surface water (A1), high water table (A2), saturation (A3), water marks (B1), and water-stained leaves (B9) were present. The hydric soil criterion was met with histosol (A1).

View facing east showing the emergent habitat of Wetland A at data point DP8, captured in the southwestern portion of the Project Area.

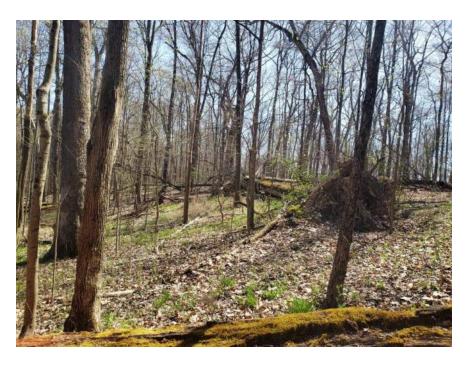
Photograph 9

View facing south showing the forested habitat at non-wetland data point DP9, captured in the western portion of the Project Area.

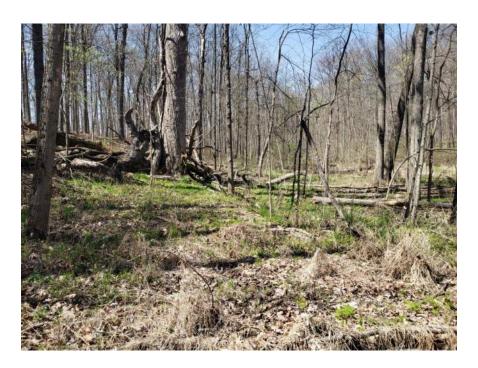
Photograph 10

View facing north showing the emergent habitat of Wetland A at data point DP10, captured in the western portion of the Project Area.
